Supplemental Service Manual

906-2150-002 Rev. C, TEXT ONLY

***Centurion** Vision System Supplemental Service Manual**

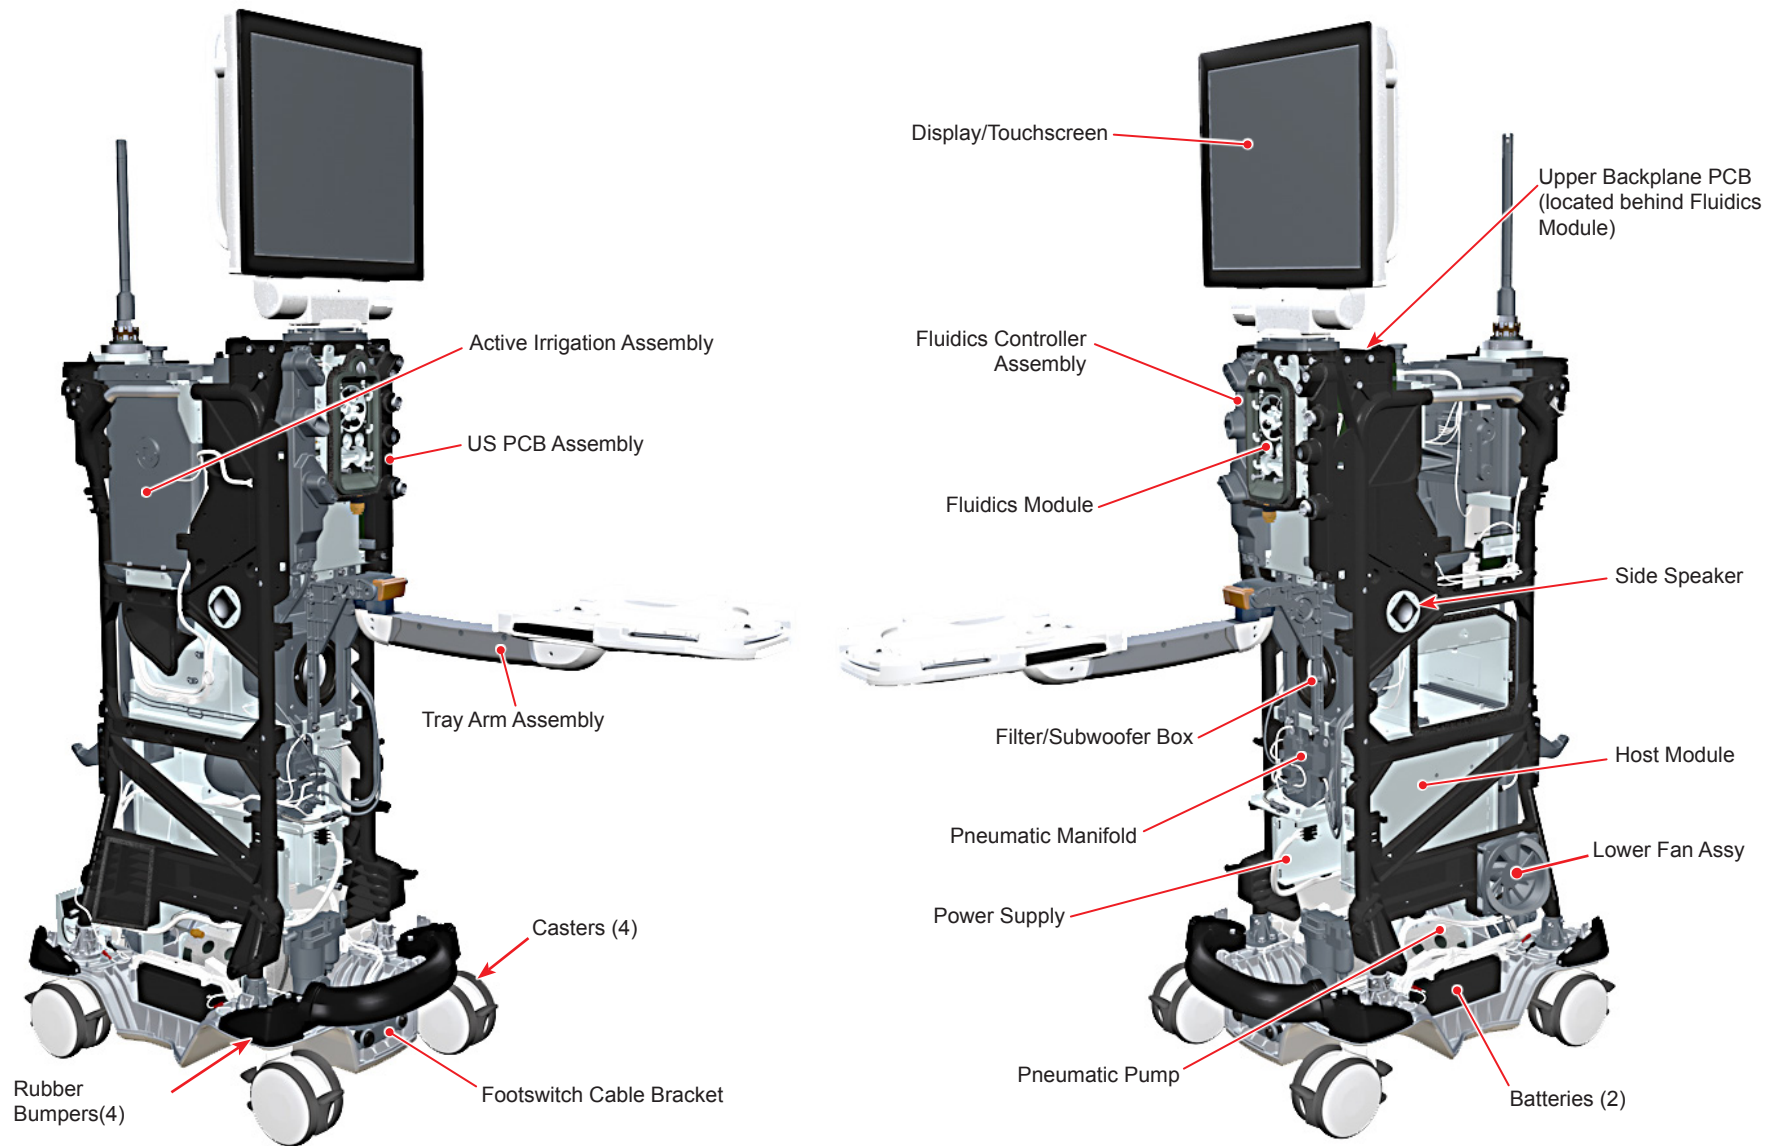
Figure 3-2 Component Location Diagram

COMPONENT LOCATION DIAGRAM - See [Figure 3-2](#)

- Left and right orientation is referred to from the console perspective
- Replacement is performed in reverse order of disassembly unless noted otherwise.
- Refer to [Figure 3-1](#) and [Figure 3-2](#) for component location.

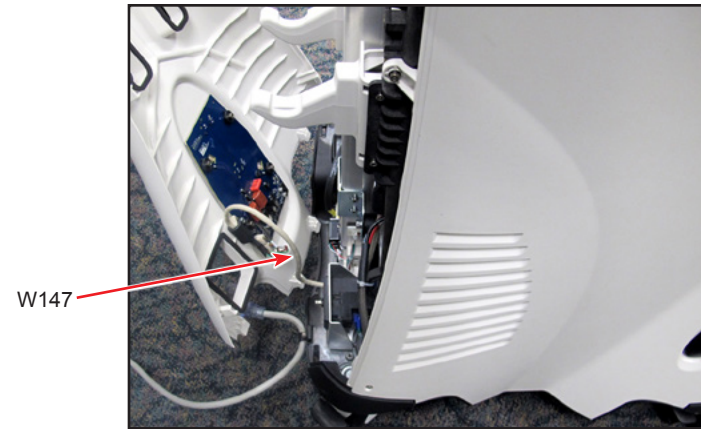
Figure 3-3 Cable W147 connecting Footswitch Charging PCB to MFIO PCB

The Footswitch Charging PCB is mounted the Lower Rear Panel and is connected to the console (MFIO PCB) by W147 (see [Figure 3-3](#)). After removal, panel can be laid flat on floor without disconnecting cable.

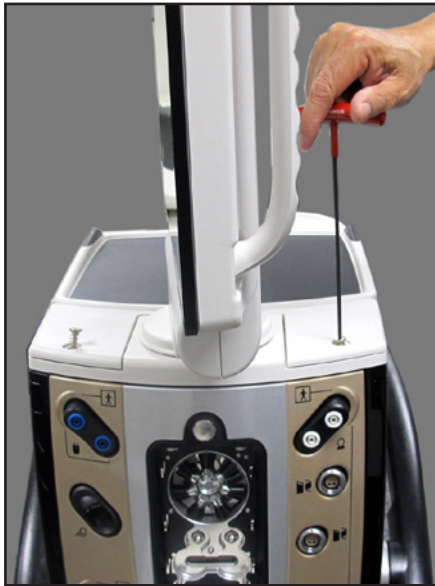
Figure 3-4 Captive Screws Securing Top of Upper Front Panel to Top Display Panel

- 4.1 Remove Front Vent Panel.
- 4.2 Turn Display as shown in [Figure 3-4](#), and loosen two 3 mm captive screws securing top of Upper Front Panel to Top Display Panel.

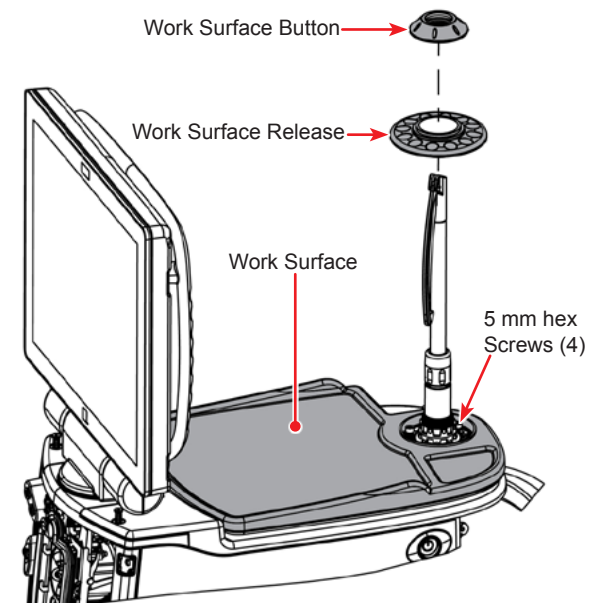
Figure 3-5 Removal of Work Surface Button and Release Button

- 8.1 Unscrew and remove Work Surface button (see [Figure 3-5](#)).

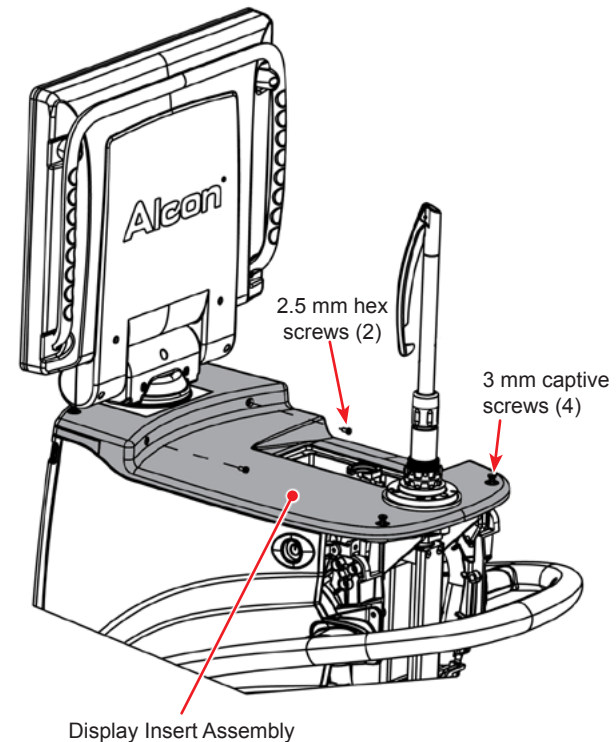
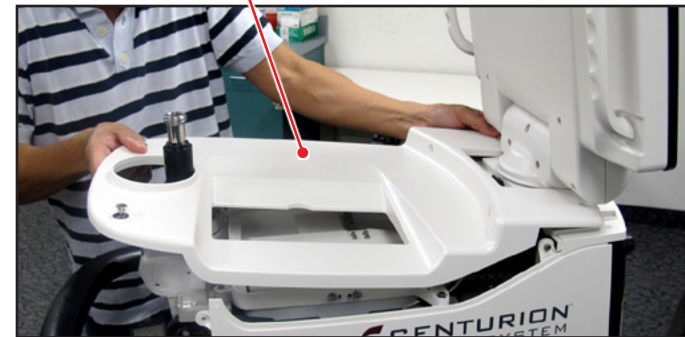
Figure 3-6 Removal of Display Insert Assembly (AS system shown)

- 9.1 Remove Work Surface (this step not applicable to Silver systems).
- 9.2 Loosen four 3 mm captive hex screws securing Display Insert to console (see [Figure 3-6](#)). Reposition Display as necessary to access screws.

- 9.3 Loosen and remove two 2.5 mm hex screws securing Display Insert to console.
- 9.4 Grasp one side of the front part of the Display Insert (near display) and the back of the panel (near the IV Pole), then lift the panel up and back until both parts of the panel have cleared the “lip” of the chassis underneath the Display Insert Panel (see photo in [Figure 3-6](#)). Leave Display Insert in this position.

NOTE: There are concealed slots in the chassis that allow the captive screws to slide with panel as it is moved.

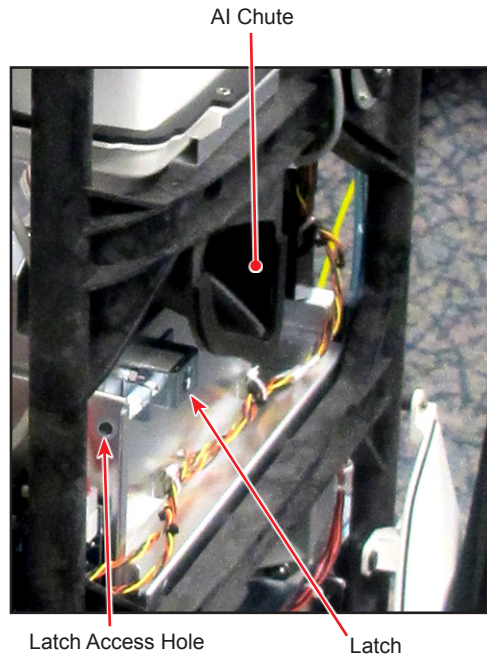
Figure 3-7 Lower Right Panel Latch Release (shown with panel removed)

- 13.1 Remove Upper and Lower Rear panels.
- 13.2 Remove Upper Right panel.
- 13.3 Remove six 3 mm hex screws and washers securing Lower Left Panel to console.
- 13.4 For original and AS systems: The panel is now held in place by a latch mechanism located just below the AI Chute in the console. The latch release is accessed from the rear through a hole in the sheet metal bracket that the MFIO PCB is mounted on (see [Figure 3-7](#)).

- 13.5 Insert a 4 mm hex wrench through the hole and into the white latch release button, then turn the button either clockwise or counter-clockwise to release the panel. Remove panel from console.

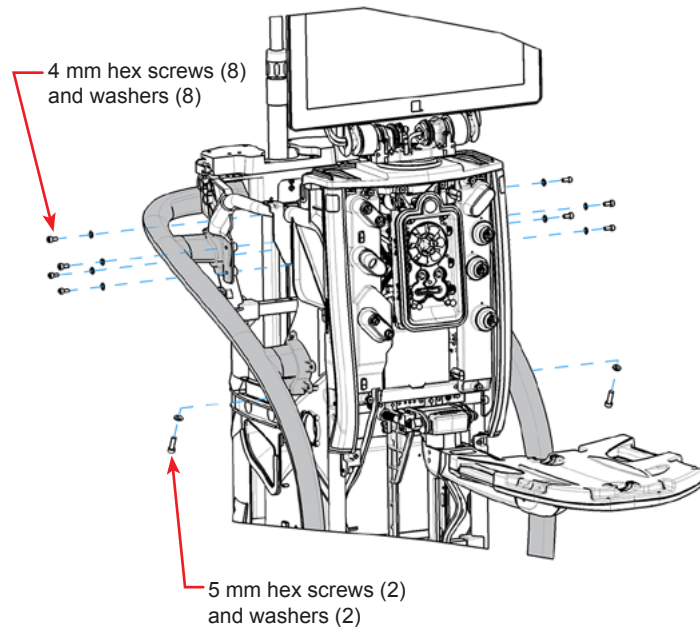
Figure 3-8 Handle Removal - Upper Screws

- 16.1 Remove Upper and Lower Front Panels.
- 16.2 Remove Upper and Lower Rear Panels.
- 16.3 Remove Upper and Lower Right Panels.
- 16.4 Remove Upper and Lower Left Panels.
- 16.5 Remove Right and Left Handle Covers.
- 16.6 Remove eight 4 mm hex screws and washers securing upper rear Handle mounts (left and right sides - see [Figure 3-8](#)).
- 16.7 Remove two 5 mm hex screws and washers securing Handle to lower front Handle mounts (left and right sides).

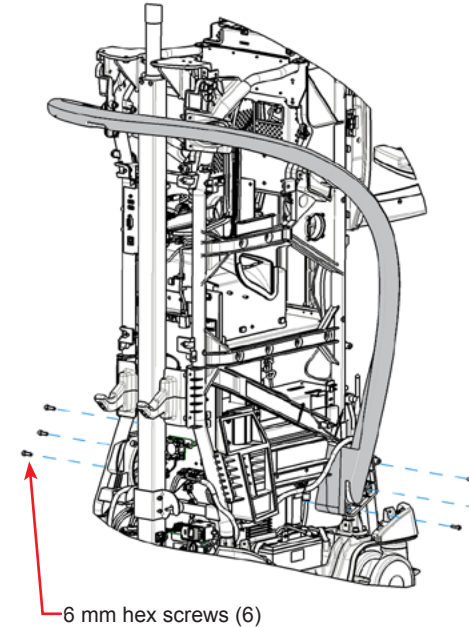
Figure 3-9 Handle Removal - Lower Screws

- 16.8 Remove six 6 mm hex screws securing Handle to the console (left and right sides - see [Figure 3-9](#)).

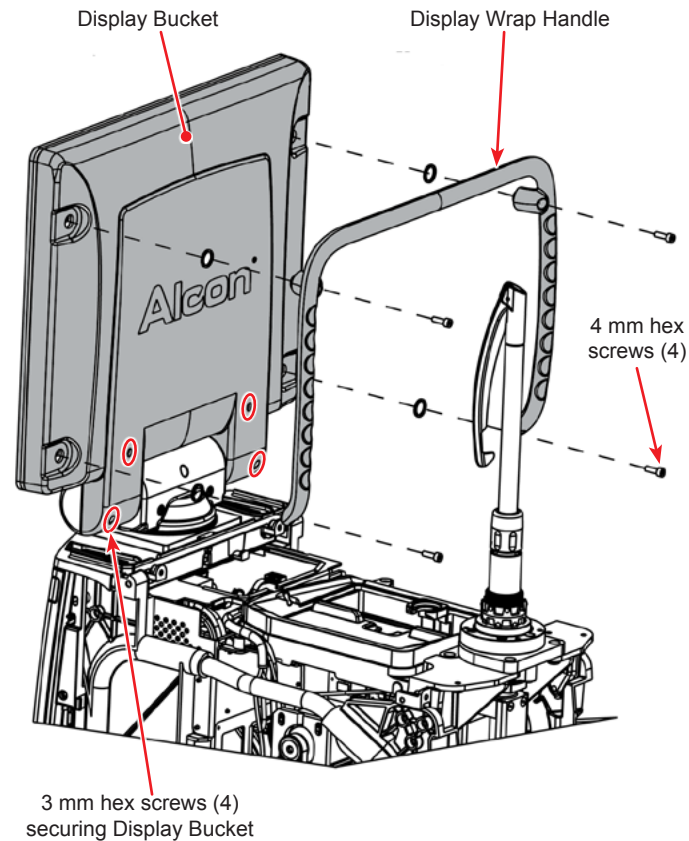
Figure 3-10 Display Wrap Handle and Display Bucket Removal

- 17.1 Remove four 4 mm screws securing Display Wrap Handle to display assembly. Remove Display Wrap Handle from system (see [Figure 3-10](#)).

- 17.2 Remove four 3 mm hex screws securing Display Bucket to display assembly. Remove Display Bucket from system.

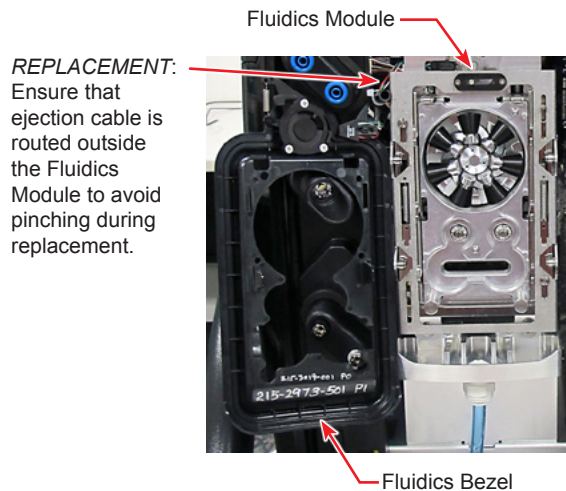
Figure 3-11 Fluidics Module with Bezel Removed

- 18.1 Remove Front Vent Panel, Upper Front Panel, and Lower Front Panel.
- 18.2 Remove black Fluidics Bezel by pulling it straight out from Fluidics Module. Bezel is attached to module by cable – allow bezel to hang freely in front of Fluidics Module during remainder of procedure (see [Figure 3-11](#)).

- Ensure that ejection cable is not pinched between Fluidics Module and console frame (see [Figure 3-11](#)).
- If Fluidics Controller Assembly (215-1007-50x) is replaced, perform the AI Travel Calibration located in Section Four of this document. If only the Fluidics PCB (215-1159-55x) is replaced, perform both the AI Travel Calibration and the Pneumatic Calibration procedures.

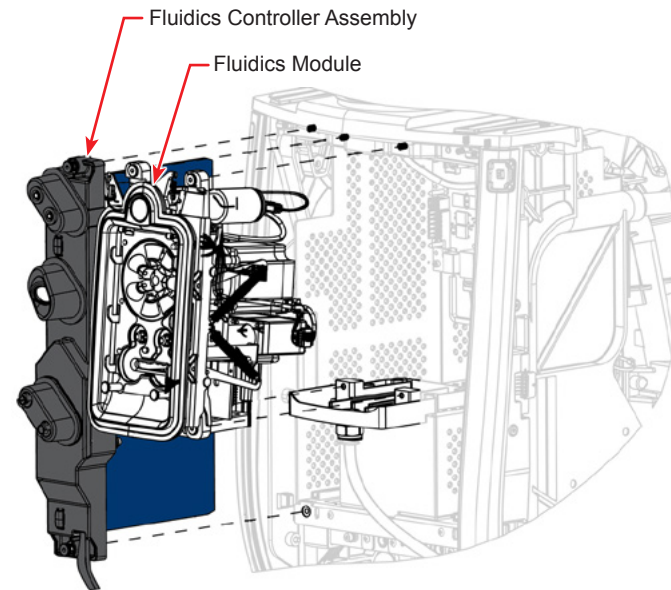
Figure 3-12 Fluidics Module and Fluidics PCB Assembly Removal

- 18.3 Loosen four 3 mm captive hex screws securing top and bottom of Fluidics Module to chassis (see [Figure 3-12](#)).
- 18.4 Loosen two 3 mm captive hex screws securing Fluidics Controller Assembly to chassis.
- 18.5 Disconnect yellow and blue pneumatic tubing from Pneumatic manifold (see [Figure 3-21](#)).

- 18.7 Disconnect J4, J5, J7, and J9 from Fluidics PCB. The two assemblies can now be separated.

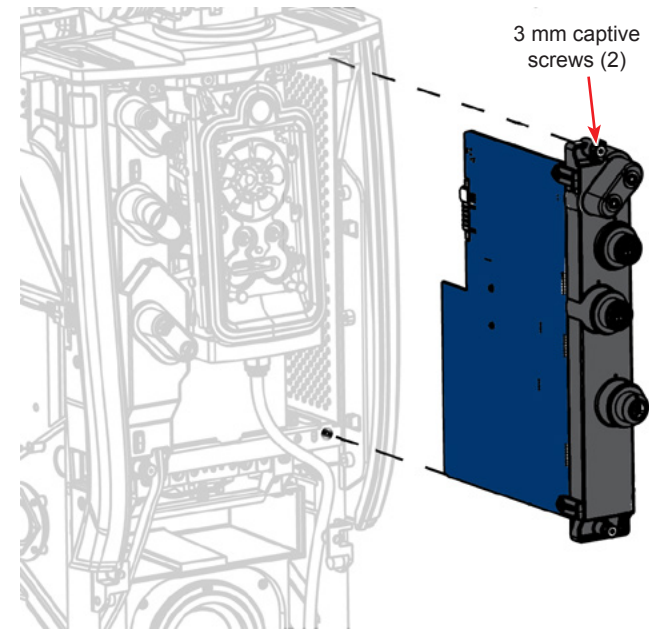
Figure 3-13 U/S PCB Assembly Removal

- 19.1 Remove Front Vent and Upper Front Panels.
- 19.2 Loosen two 3 mm captive hex screws securing top and bottom of U/S PCB Assembly to chassis.
- 19.3 Pull U/S PCB Assembly straight out from console and remove ([Figure 3-13](#)).

- Carefully slide assembly into place making slight adjustments as necessary to ensure PCB seats properly into upper backplane. Handpiece connector cables may need to be repositioned while assembly is sliding into place.
- When securing assembly to console, alternately tighten screws to ensure proper seating of PCB.
- HP Connector removal uses same tool as *Infiniti** Vision System.

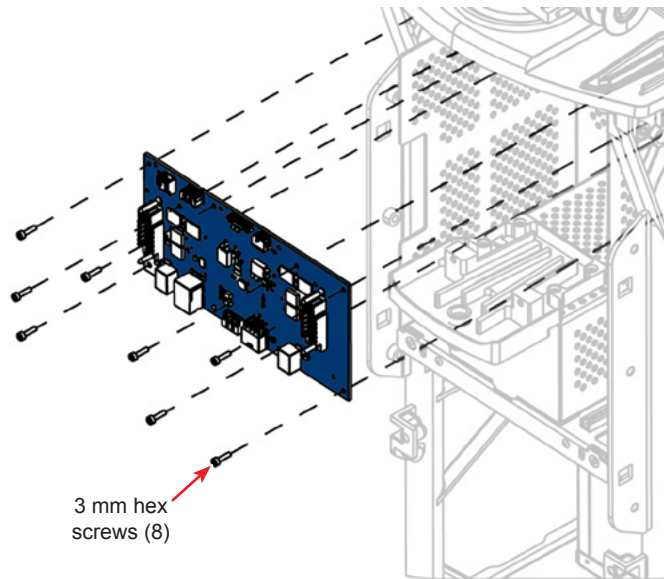
Figure 3-14 Upper Backplane PCB Removal

- 20.1 Remove Front Vent and Upper Front Panels.
- 20.2 Remove Fluidics Mechanism, Fluidics PCB, and U/S PCB Assemblies.
- 20.3 Disconnect J12, J16, J10 (may require screwdriver), J11, J4, J3, and J9 from Upper Backplane PCB.
- 20.4 Remove eight 2.5 mm hex screws securing Upper Backplane PCB to console.
- 20.5 Carefully pull Upper Backplane PCB off guide posts, rotate to clear display cables, and remove from system ([Figure 3-14](#)).

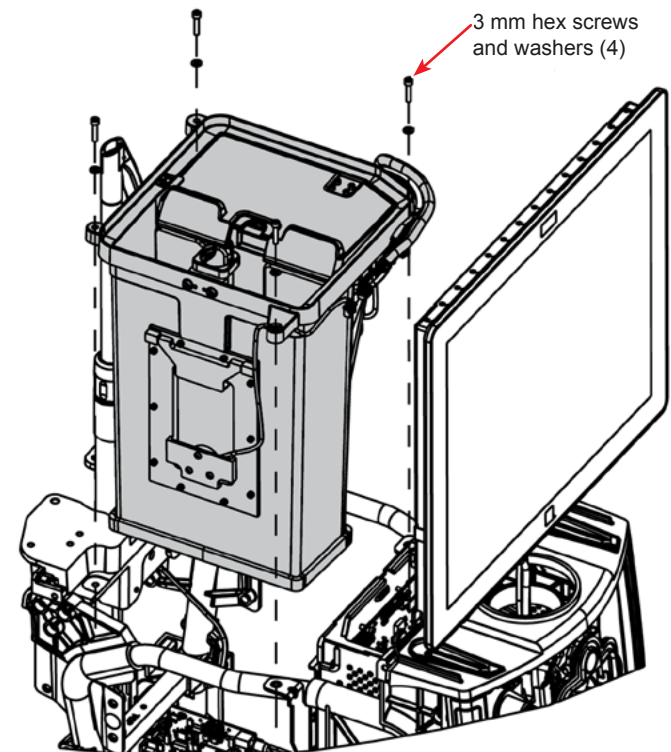
Figure 3-15 Active Irrigation Assembly Removal

- 21.1 Remove Display Insert Panel.
- 21.2 Disconnect J10, J11, J12, and J16 from Upper Backplane PCB.
- 21.3 Remove four 3 mm hex screws and washers securing AI Assembly to console.
- 21.4 Pull AI Assembly up and out of chassis moving the assembly as necessary to gain clearance for removal (see [Figure 3-15](#)).

REPLACEMENT: When lowering AI Assembly into console, ensure clearance of all cables. Assembly should not rest on or "pinch" any cables.

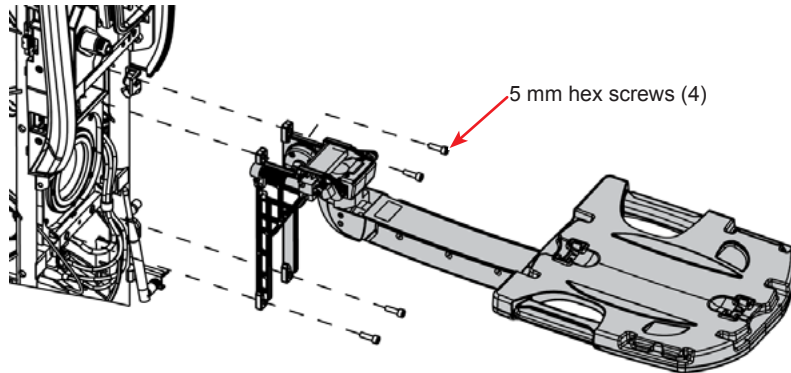
Figure 3-16 Tray Arm Assembly Removal

- 22.1 Remove Front Vent, Upper and Lower Front Panels.
- 22.2 Remove four 5 mm hex screws (bottom screws first) securing Tray Arm Assembly to chassis and remove from console (see [Figure 3-16](#)).

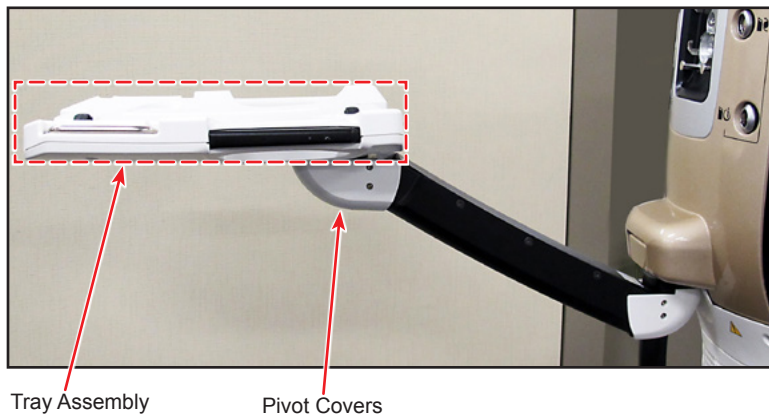
Figure 3-17 Tray Assembly at Highest Position

- 23.1 Raise the Tray Assembly to the highest position as shown in [Figure 3-17](#).

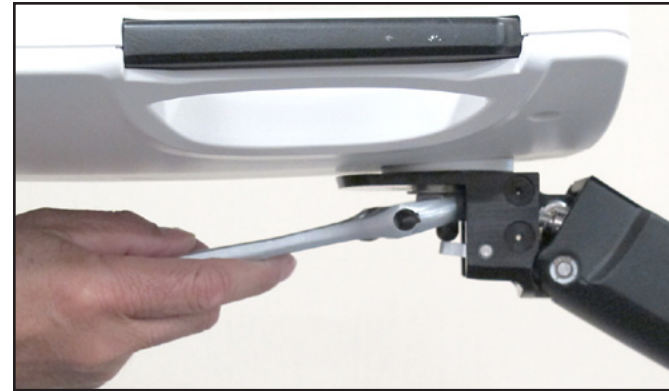
Figure 3-18 Tray Assembly Nut Removal

- 23.2 Remove four 2 mm hex screws securing left and right Pivot Covers. Remove covers from tray arm assembly.
- 23.3 Remove 1 inch nut securing Tray Assembly to Arm (see [Figure 3-18](#)). Be aware that there are washers and bearings behind the nut that may drop as the nut is removed (see [Figure 3-19](#)).

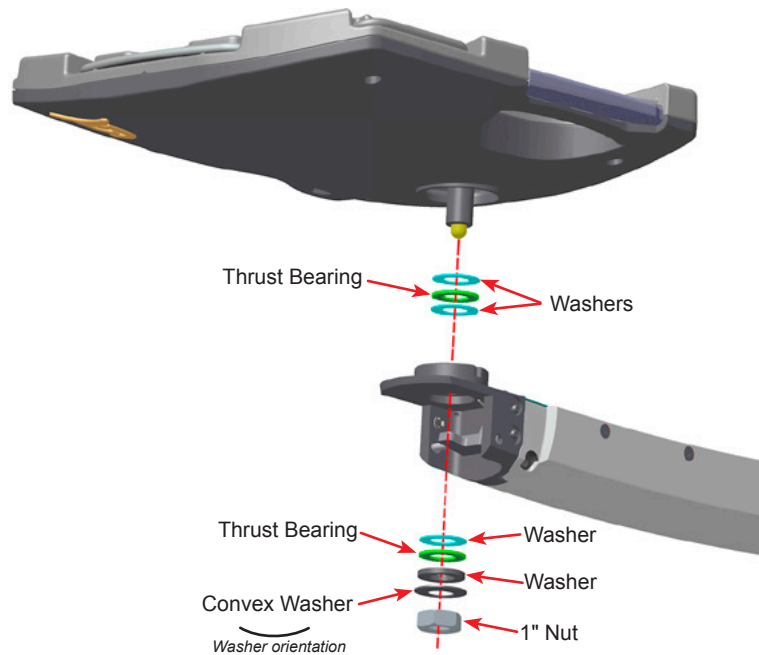
Figure 3-19 Washers and Bearings used to attach Tray Assembly to the Tray Arm

There are five washers and two bearings used to attach the tray assembly to the arm (see [Figure 3-19](#)). Ensure these washers and bearings are installed in the proper orientation otherwise the Tray Arm Assembly may not function properly.

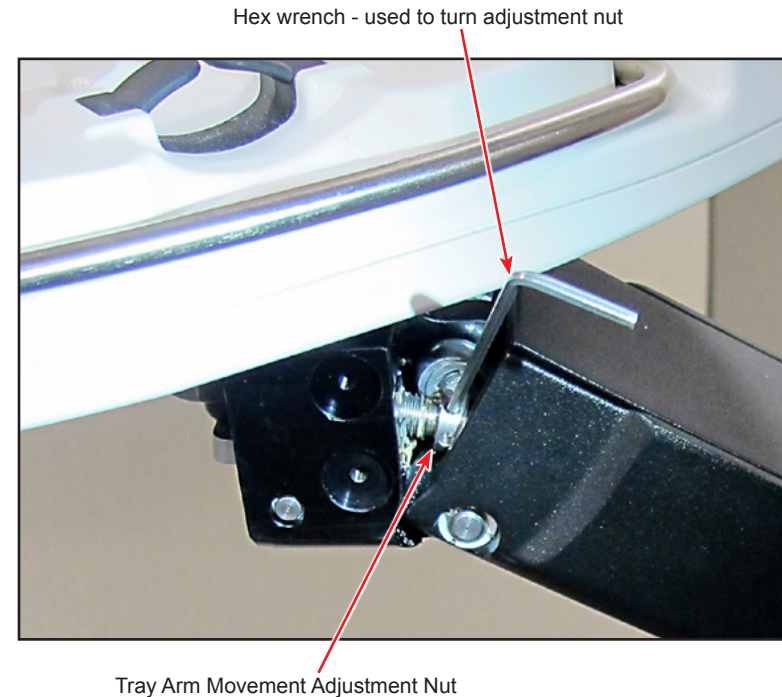
Figure 3-20 Adjusting Tray Arm Movement

- 23.6 Fully tighten 1 inch nut then loosen ½ turn.
- 23.7 Test Tray Arm movement to ensure it is working properly.
- 23.7.1 If Tray Arm is not moving properly when handles are pressed (unlocked), turn the adjustment nut backwards or forwards until it does move properly (see [Figure 3-20](#)). Ensure Tray Arm locks in position when handles are released and unlocks when handles are pressed.

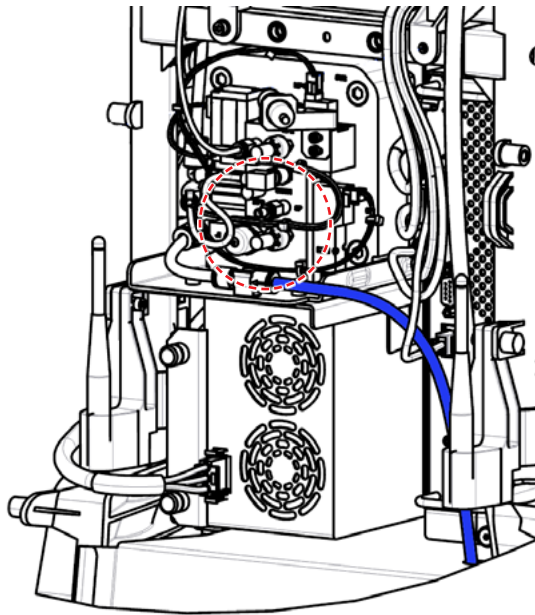
Figure 3-21 Pneumatic Tubing Connecting Pneumatic Manifold and Vit Pump

- 24.1 Remove Front Vent, Upper and Lower Front Panels.
- 24.2 Disconnect blue tubing between Pneumatic Manifold and Vit Pump (see [Figure 3-21](#)).
- 24.3 Disconnect yellow and blue tubing between Pneumatic Manifold and Fluidics PCB Assembly (see [Figure 3-22](#)).
- 24.4 Disconnect four electrical connectors (includes A28SENS1) from Pneumatic Manifold. Connectors are part of cable W133 which connects to the MFIO PCB at J8.
- 24.5 Loosen two 3 mm captive hex screws securing Pneumatic Manifold to chassis (see [Figure 3-23](#)).
- 24.6 Slide Pneumatic Manifold forward and remove from console.

- 26.4 Disconnect blue tubing from Pneumatic Manifold (provides clearance to remove Host module - see [Figure 3-21](#)).
- 26.5 Loosen two 2.5 mm captive screws securing Host Module to chassis (see [Figure 3-26](#)).

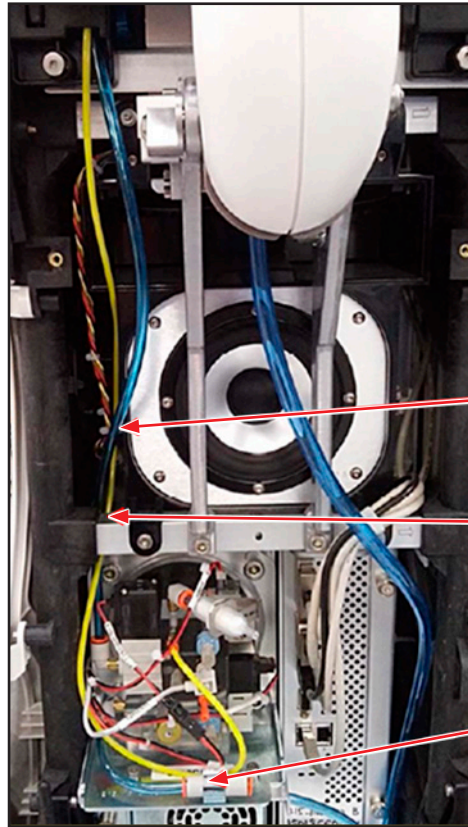
Figure 3-24 Pneumatic Tubing Routing

NOTE: For systems with new Pneumatics Main Manifold PN 215-3337-501, route the 28" yellow tubing as shown in [Figure 3-24](#) to prevent the tubing from getting pinched by the Front Panel.

Yellow tubing routing goes behind cable tie mount on filter box (215-1796-501). Blue tubing routing goes in front of cable tie mount.

Yellow tubing routing goes behind cross member on frame (215-1004-003). This is the same routing as for the blue tubing.

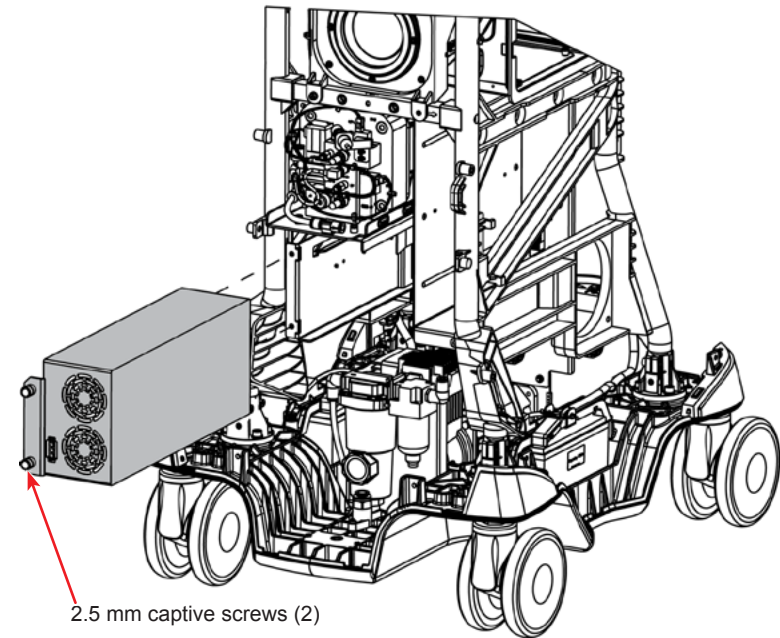
Figure 3-25 Power Supply Removal

- 25.1 Remove Front Vent, Upper and Lower Front Panels.
- 25.2 Disconnect W111 P1 from Power Supply.
REPLACEMENT: Antenna should be pointing up with Power Supply cable routed around it.
- 25.3 Loosen two 2.5 mm captive hex screws securing Power Supply to chassis (see [Figure 3-25](#)).
- 25.4 Slide Power Supply forward, adjusting position as necessary to clear antenna, and remove from console.

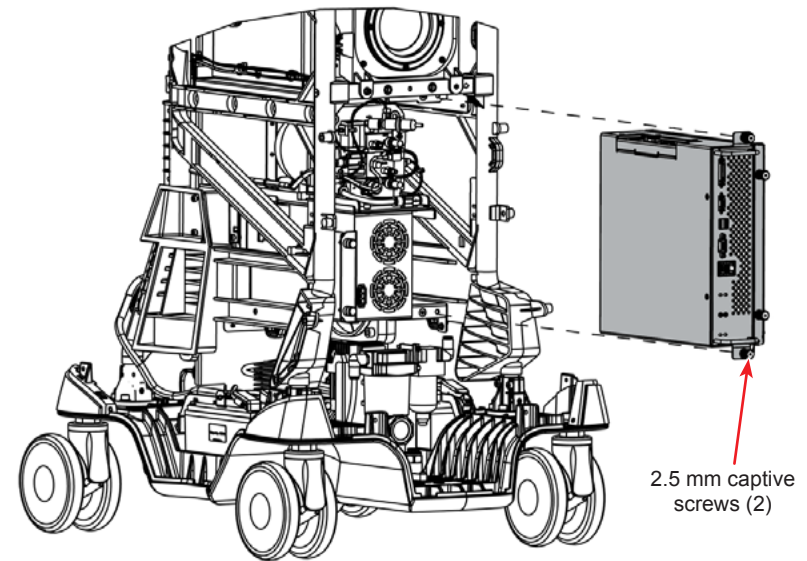
Figure 3-26 Host Module Removal

- 26.6 Pull Host Module forward while repositioning pneumatic tubing and cables to provide clearance for module removal. Remove Host Module from console.
REPLACEMENT: Carefully slide Host Module into console until it engages connector and is properly seated in place.

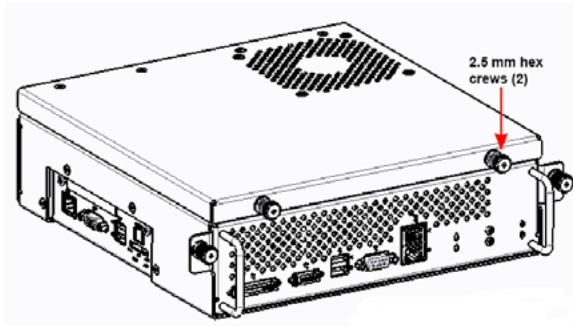
Figure 3-27 Screws Securing Host Module Cover

- 27.1 Remove Host Module.
- 27.2 Loosen two 2.5 mm hex captive screws securing the Host cover (see [Figure 3-27](#)), and then open the Host cover.

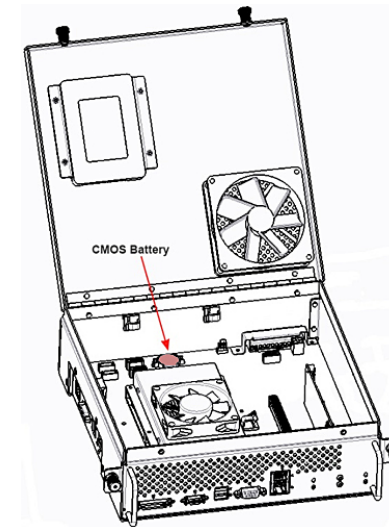
Figure 3-28 Host Module Battery Location

- 27.3 Remove battery BT1 (CR2032) from Host PCB by lifting one side of the coin battery and then pulling it out (see [Figure 3-28](#)).

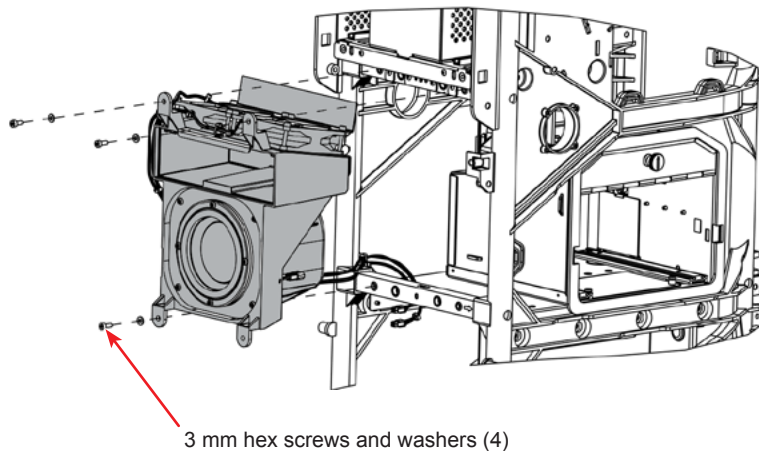
Figure 3-29 Filter/Subwoofer Box Removal

- 28.1 Remove Front Vent, Upper and Lower Front Panels.
- 28.2 Disconnect J1 from Sub-woofer.
- 28.3 Disconnect J18 and J35 from MFIO PCB.
- 28.4 Cut tie wraps securing W129-1 and W129-2 to chassis.
- 28.5 Remove four 3 mm hex screws and washer securing Sub-woofer/fan assembly to chassis (see [Figure 3-29](#)).
- 28.6 Carefully pull Filter/Subwoofer Box forward to remove from system.
- 28.7 FAN REMOVAL
 - 28.7.1 To remove fans from assembly, remove four 3 mm hex screws securing bracket to assembly.
 - 28.7.2 Remove two 3 mm hex screws securing front of fans to assembly. Cut tie wraps as necessary and remove fan(s).

- 2.4 Lift panel up to clear tabs securing bottom of panel, then remove from console. Lay panel on floor next to console.
- 2.5 *To completely remove panel from system:*
 - 2.5.1 Remove 40 A fuse on MFIO PCB (see [Figure 3-29](#)).
 - 2.5.2 Disconnect cable W147 from console connectors J25 and J39 of MFIO PCB.
- NOTE: Do not cut cable ties unless cable is being replaced.**
- 2.6 Remove Footswitch Charging PCB ([step 36](#)) from the Lower Rear Panel and install it on the new Lower Rear Panel.

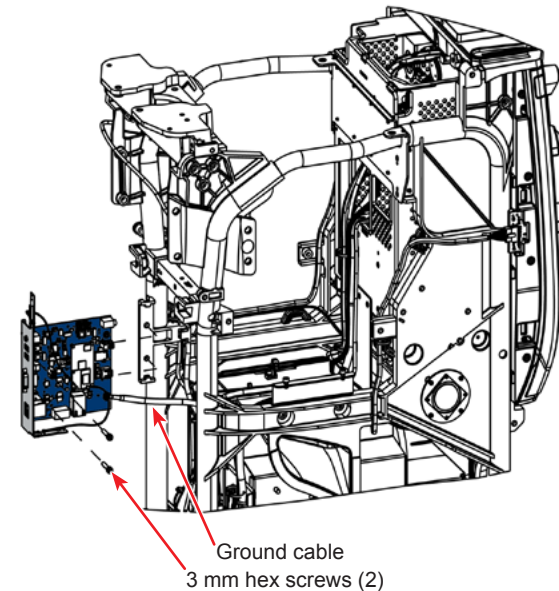
Figure 3-30 Rear Panel I/O-Wireless Module Assembly Removal

- 29.1 Remove Upper Rear, Lower Rear, and Upper Left Panels.
- 29.2 Remove 40 A fuse from MFIO PCB (in case hardware is dropped).
- 29.3 Disconnect J4, J5, J7, and J10 from Wireless PCB.
- 29.4 Remove 2.5 mm hex screw and star washer securing ground terminal lug to Wireless PCB.
REPLACEMENT ORDER: From PCB – star washer/terminal lug/hex screw
- 29.5 Remove two 3 mm hex screws securing Rear Panel I/O-Wireless Module Assembly to chassis (see [Figure 3-30](#)). Screws are accessed from inside chassis; removal of lower right panel may be necessary.
- 29.6 Slide Rear Panel I/O-Wireless Module Assembly straight back and out of console.

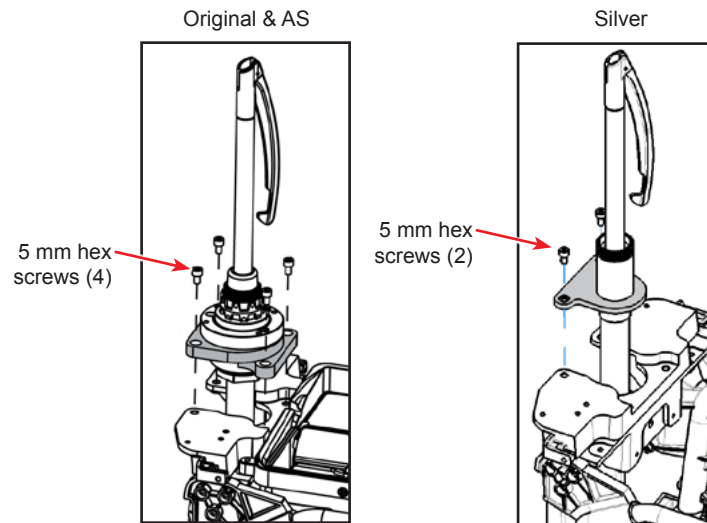
- 30.1 Remove Work Surface (not applicable to Silver systems).
- 30.2 Remove Display Insert Assembly.
- 30.3 Remove Upper and Lower Rear Panels.
- 30.4 **For Original and AS systems:** Remove four 5 mm hex screws securing work surface hub at top of IV Pole Assembly to chassis. Slide hub up and remove from IV Pole Assembly (see [Figure 3-31](#)).

For Silver systems: Remove two 5 mm hex screws securing threaded sleeve mount at top of IV Pole Assembly to chassis. Slide mount up and remove from IV Pole Assembly (see [Figure 3-31](#)).

Figure 3-31 Work Surface Hub Removal

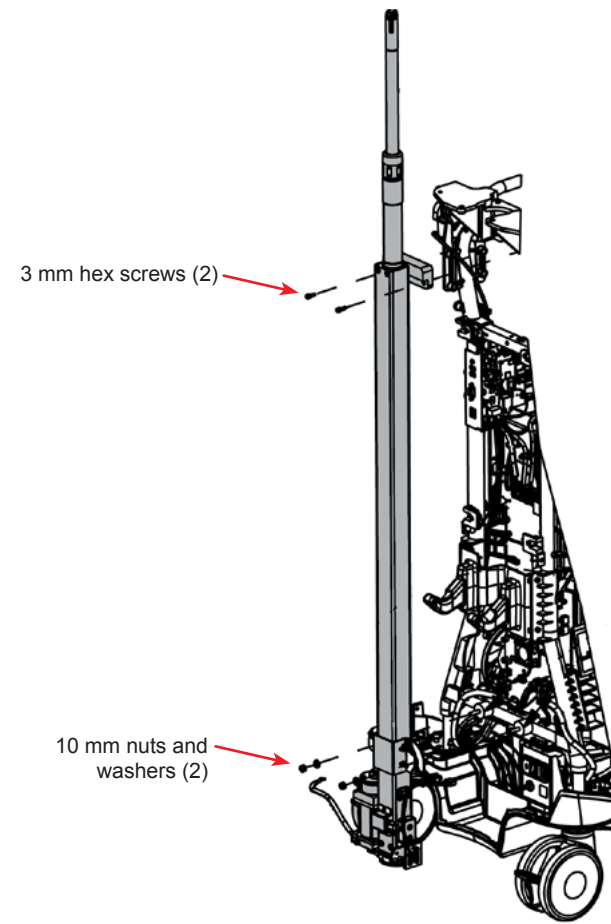
- 30.5 Remove two 3 mm hex screws securing inside top of IV Pole Assembly to chassis (see [Figure 3-32](#)).

- 30.6 Loosen two 10 mm nuts and washers securing bottom of IV Pole Assembly to standoffs on chassis. Nut do not need to be completely removed (see [Figure 3-32](#)).
- REPLACEMENT:** Do not tighten nuts until two 3 mm hex screws at inside top of assembly are in place.
- 30.7 Disconnect J5 and J23 from bottom of MFIO PCB.
 - 30.8 Remove 3 mm hex screw securing ground terminal lug to IV Pole Assembly.
 - 30.9 Lift IV Pole Assembly upward until there is enough clearance to remove assembly from console.

Figure 3-32 IV Pole Assembly Removal

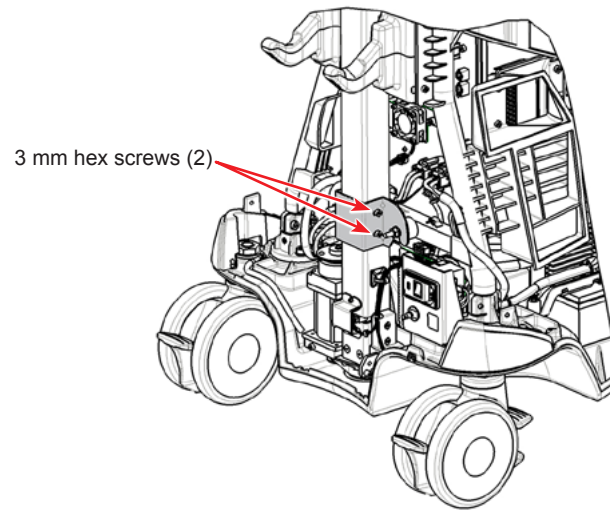
- Before installing the IV Pole, loosen the two 3 mm hex screws identified in [Figure 3-33](#).
- After the IV Pole is replaced, fully tighten the two 3 mm hex screws identified in [Figure 3-33](#).

Figure 3-33 IV Pole Assembly Replacement

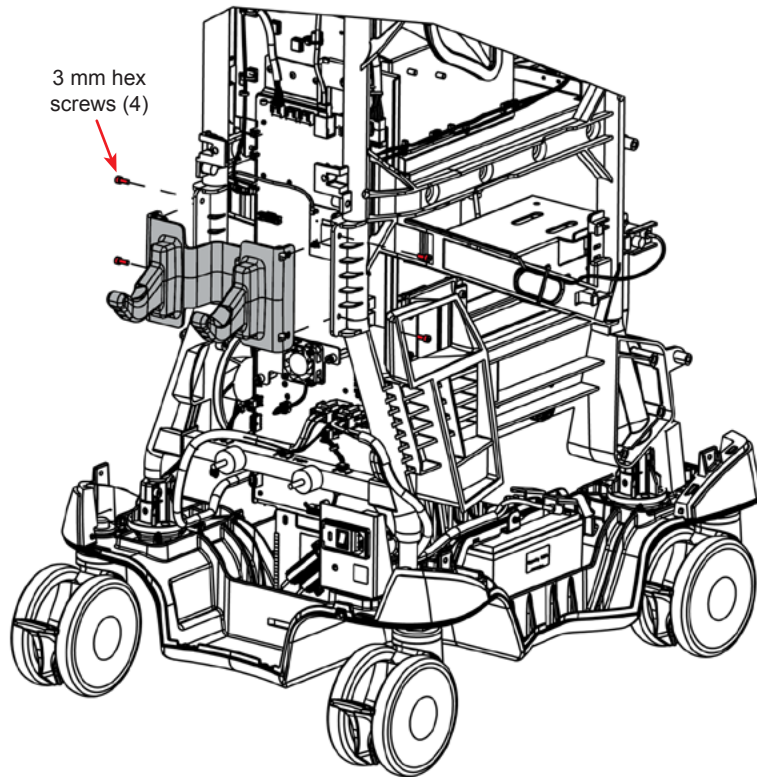
- 31.1 Remove Upper and Lower Rear Panels.
- 31.2 Remove four 3 mm hex screws securing footswitch hanger to chassis (see [Figure 3-34](#)).
- 31.3 Slide Footswitch Hook up to provide clearance then rotate around IV Pole and remove from console.

Figure 3-34 Footswitch Hook Removal (shown with IV Pole removed)

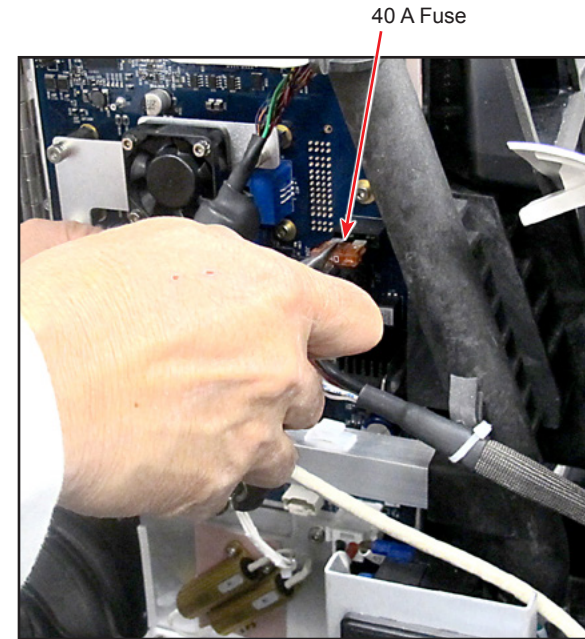
- 32.1 Remove Upper and Lower Rear Panels.
- 32.2 Remove Footswitch Hook.
- 32.3 Remove 40 A fuse from MFIO PCB (see [Figure 3-35](#)).

Figure 3-35 40 A fuse on MFIO PCB

- 33.1 Remove Upper and Lower Rear Panels.
- 33.2 Remove Footswitch Hook.
- 33.3 Remove 40 A fuse from MFIO PCB (see [Figure 3-35](#)).
- 33.4 Remove battery BT1 (CR 2032) from MFIO PCB by pulling clip away from battery, then sliding the battery forward. See [Figure 3-36](#) for battery location.

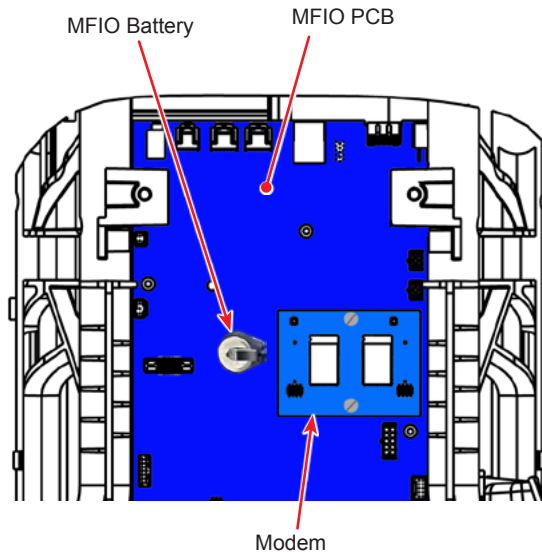
- 32.4 Disconnect modem connectors J1 and J4.
- 32.5 Carefully remove two standard screws securing Modem PCB to MFIO PCB (see [Figure 3-36](#)).
- 32.6 Pull Modem PCB off two connectors on MFIO PCB and remove from console.

Figure 3-36 MFIO Modem Removal

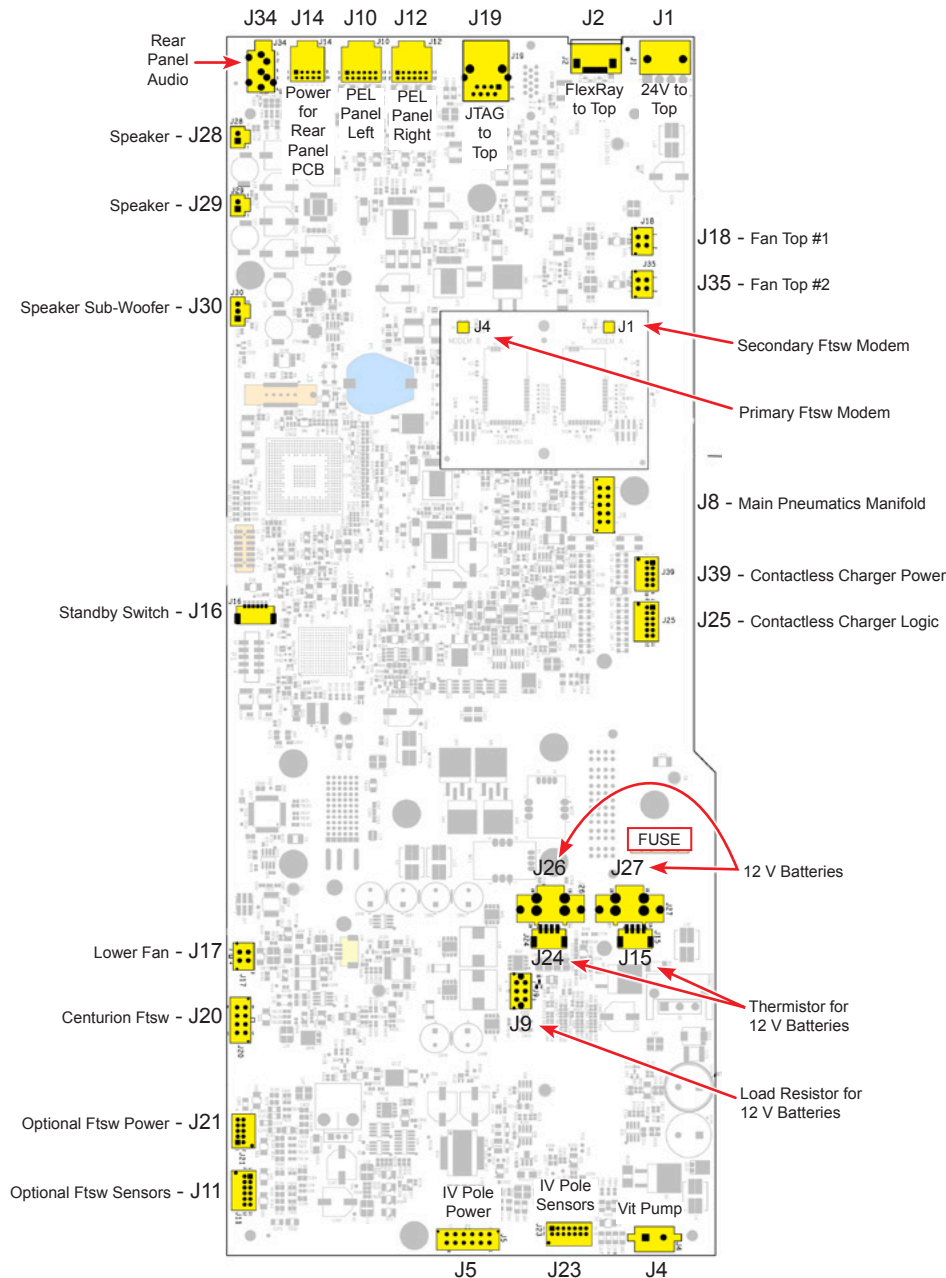
- 34.1 Remove Work Surface and Display Insert Assembly.
- 34.2 Remove Upper and Lower Rear Panels.
- 34.3 Remove IV Pole Assembly.
- 34.4 Remove Footswitch Hook.
- 34.5 Remove 40 A fuse from MFIO PCB.
- 34.6 Disconnect the connectors shown in yellow in [Figure 3-37](#).
- 34.7 Disconnect antenna cables at J1 and J4 from MFIO Modem PCB.
- 34.8 Disconnect Fan connector J38 from MFIO PCB.
- 34.9 Loosen three 3 mm captive hex screws securing Fan assembly to MFIO PCB. Remove fan assembly.
- 34.10 Remove three Fan assembly standoffs from MFIO PCB.
- 34.11 Remove seven 3 mm hex screws securing MFIO PCB to chassis.
- 34.12 Reposition MFIO PCB as necessary to remove from system.

Figure 3-37 MFIO PCB Connector Diagram

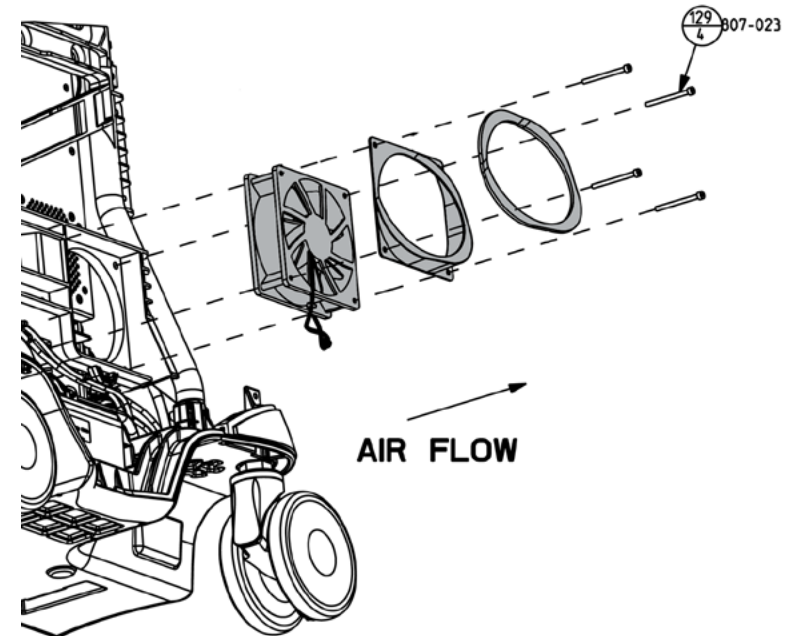
- 35.1 Remove Upper and Lower Rear Panels.
- 35.2 Remove Upper and Lower Left Panels.
- 35.3 Remove four 3 mm hex screws securing fan and duct to chassis (see [Figure 3-38](#)). **NOTE: Fan is still connected to MFIO PCB by cable.**
- 35.4 Pull fan from console and disconnect from J17 on MFIO PCB.

Figure 3-38 Lower Fan Assembly Removal

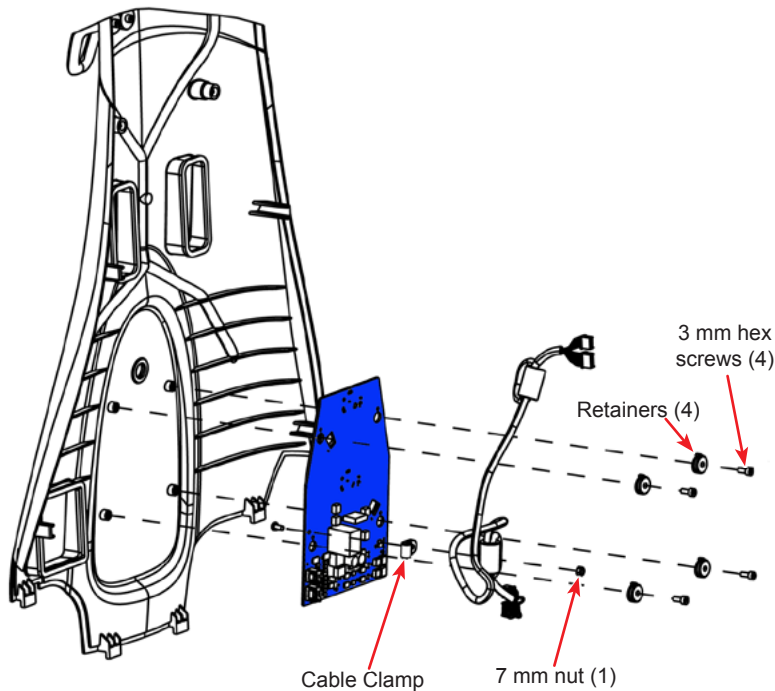
- 36.1 Remove Upper and Lower Rear Panel.
- 36.2 Disconnect J1 and J2 from Footswitch Charger PCB.
- 36.3 Remove 7 mm nut and star washer securing cable clamp for W147 to panel (see [Figure 3-39](#)).
- 36.4 Remove four 3 mm hex screws and black retainers securing Footswitch Charger PCB to panel.

Figure 3-39 Footswitch Charger PCB Removal

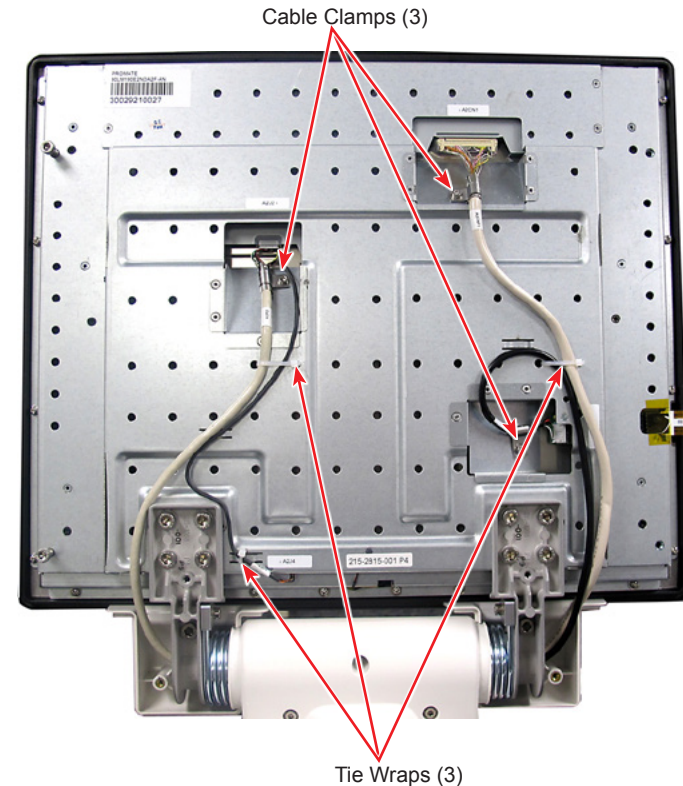
- 37.1 Remove Display Wrap Handle and Display Bucket.
- 37.2 Cut three tie wraps securing cables W104-CNP1, W103-P2 and P4, and W126-P1 to Display Assembly (see [Figure 3-40](#)).
REPLACEMENT: Note cable routing as shown in [Figure 3-40](#).

Figure 3-40 Display Cable Routing

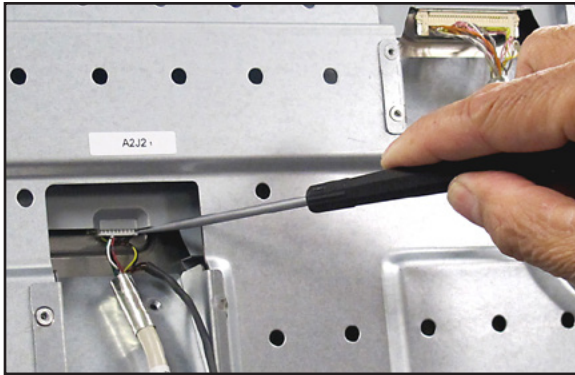
- 37.3 Remove three 2.5 mm hex screws securing cable clamps to Display Assembly.
- 37.4 Carefully disconnect CNP1 (squeeze latch on each side to release), P2, P4, and P1 from Display Assembly. **NOTE: A thin blade screwdriver will aid in loosening connector as shown in [Figure 3-41](#).**

Figure 3-41 Display Connector Removal

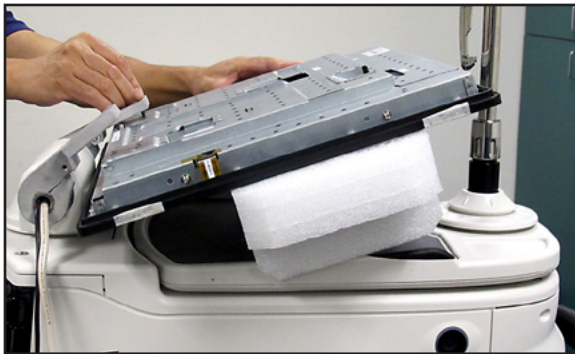
- 37.5 Place Display in the stored position with a piece of the foam packaging from new Display under the old Display as shown in [Figure 3-42](#).

Figure 3-42 Display Supported by Foam Packaging

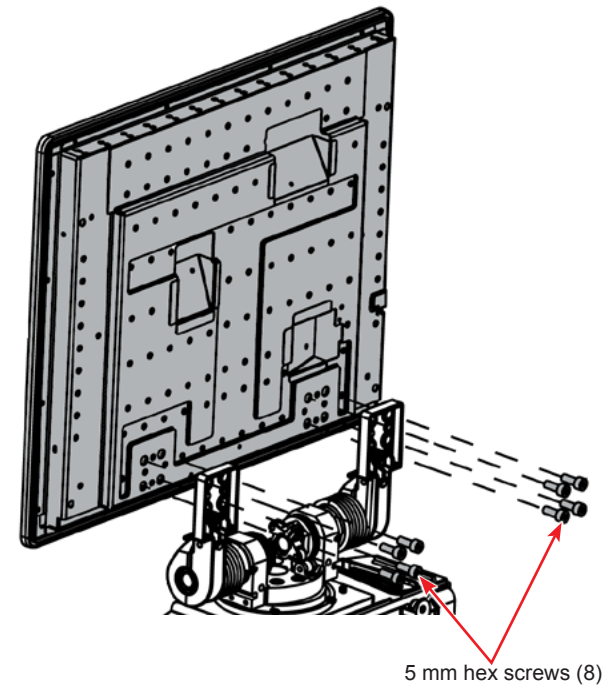
- 37.6 Remove eight 5 mm hex screws securing Display Assembly to console (see [Figure 3-43](#)). **NOTE: Hinge covers will come off when display is removed.**

Figure 3-43 Display Removal
